VOL. 1 NO. 3

# CONTENTS

The contents of this News Letter will bring you up to date on changes and corrections made since issue No. 2 was sent out. We want to make the News Letter as useful and as interesting as possible. You can help us do this by sending in your comments and suggestions. Send your recommendations to the 9Xtra News Letter, cfo United Motors Service Division, 3044 W. Grand Boulevard, Detroit 2, Michigan, Department R9X.

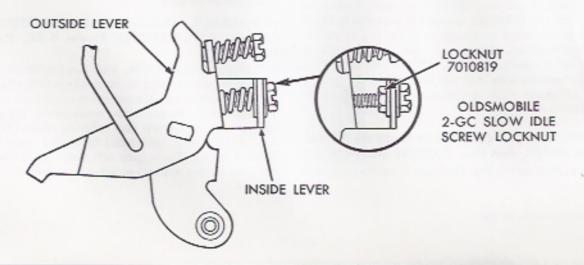
# OLDSMOBILE, 1956—ADDITION OF LOCKNUT TO SLOW IDLE ADJUSTMENT SCREW. Model 2-GC, Part Nos. 7007223 & 7008800

Reference: Bulletin 9C-507. The slow idle adjustment screw compression spring has been replaced by a locknut to make the idle screw hold its setting more positively. The locknut, Part No. 7010819, can be easily installed on carburetors in the field where a fix is necessary. To install the nut, first unbook the throttle linkage at the carburetor to relieve the pressure on the throttle lever. Next, unscrew the idle adjustment screw from the threaded hole in the outside lever and remove the compression spring, leaving the screw and its two flat washers on the inside lever (See illustration). Spin the locknut on the adjustment screw a short distance and start the idle screw back into the threaded hole in the outside lever.

Turn the screw in about six turns and tighten the locknut with the fingers to hold the screw firmly in the outer lever. Then, hold the choke valve wide open to keep the fast idle adjusting screw off the fast idle cam and with throttle valves fully closed, turn the idle adjustment screw in until throttle valves just begin to open. Turn the screw in one additional full turn, tighten locknut against throttle lever and reconnect the throttle linkage. Recheck idle speed setting with the engine fully warmed up and running. If idle speed is not correct loosen the locknut and readjust the idle screw. In an emergency, a standard 10-32 steel hex nut may be used in place of Part No. 7010819. However, the special locknut has a smaller hex size to allow more room for tightening.
